Mineral Solid Lubricant Coatings Nano-Material Based Anti-Friction Technology

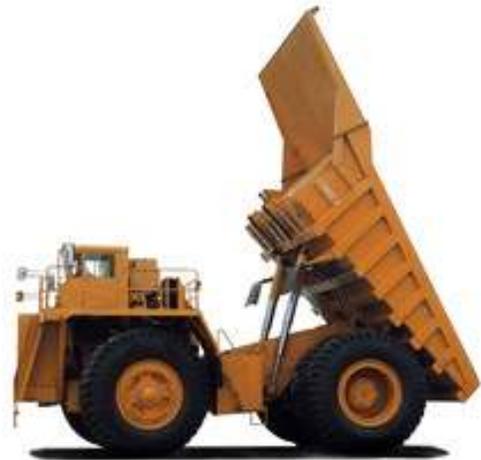
Case 2. Open-pit dump truck BELAZ-7519

According to the analysis of the open-pit autoservice group, a dump truck BELAZ-7519 worn out by ~70 % was analyzed. It was exploited on the same route, and it was easy to monitor fuel consumption rate. The truck was consuming **3 800 l/month more than standard** fuel consumption declared by the manufacturer. A decision was made to write it off. It was decided to try our new anti-friction technology for this truck.

Two months after anti-friction treatment, it was found out that the consumption of fuel for this truck was **700 l/month lesser than the standard** consumption (marked for a truck with this level of kilometers run and the worn-out level). Thus, the total fuel savings as a result of application of mineral solid lubricant were **4 500 l per month**. The decision to write it off was immediately canceled as the dump truck had a minimum fuel consumption in the open-pit truck fleet.

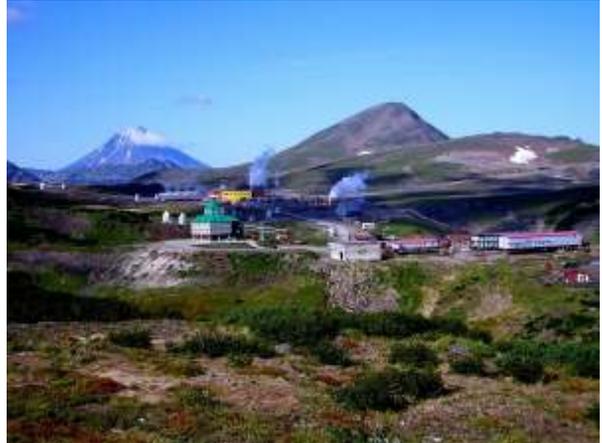
Case 3. Kamchatka Geothermal Power Plant

Anti-friction technology was tested and exploited at a large industrial enterprise - manufacturer of power generation equipment "KTZ" (Joint Stock Company "Kaluga Turbine Works"). The company had produced power generation equipment for Kamchatka Geothermal Power Plant; however, friction pairs were easily oxidized in aggressive environment (hot vapour at 240 °C with H₂S and salts) and needed repair every 3 months. After application of mineral coatings to the friction pairs, the equipment worked for **10 years** without any problems and is still running. Service time increased **40 times**.

Tests of metal parts and units for **turbines and pumps** with mineral coatings have been made at KTZ during these 10 years. Efficiency and reliability were tested for **bearings of turbo generators, pumps** with water lubrication and **regulating and protecting units**. The products with mineral coatings showed high reliability. Wear decreased 5 times. The products work in most unfavourable conditions: in aggressive media, in conditions of limited aqueous lubrication, border friction and abrasive wear. The tests and prolonged exploitation showed substantial advantages of mineral coatings in reliability, service life, labour intensity and time of manufacturing.

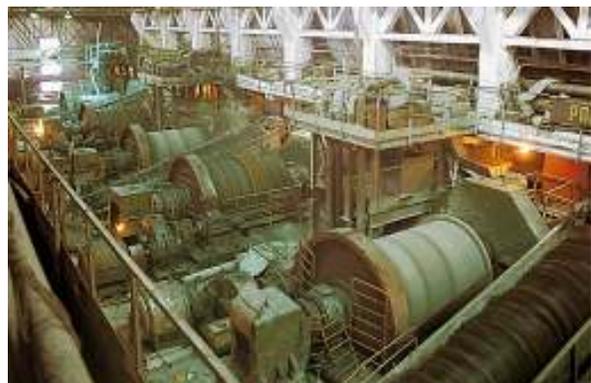
Case 9. Ball mill

Ball mill MShR 4,5*5.0 is designed to crush ore lumps and consists of the following parts: drum (bowl) on two supporting slider bearings, tooth gearwheel of the drum, gearshaft on spherical bearings 3680, box-coupling, electric engine drive on two slider bearings. Lubrication is provided by forced-feed lubrication system with an oil reservoir of 250 l.

Inspection of the ball mill revealed several defects: tooth gearwheel and gearshaft were worn (30 % of the thickness of tooth); all teeth of the tooth gearwheel had wear cavities of 30-40 mm width. During inspection initial parameters of the ball mill (current of idle running, slowing time after switching off) were measured.

Antifriction technologies were applied to the bearings and gears of the ball mill. Furthermore, dispersion of mineral powder was added to the lubricating oil reservoir.

- current of idle running diminished from **140 A** to **85 A** (friction losses by 39 % less);
- slowing time after switching off increased from **7-10 sec** to **35-45 sec** (3 measurements were performed).

After 2.5 months, additional antifriction treatment of spherical bearings and tooth gearwheel was done. Running-in was performed for 1 hour in the routine working regime. After switching off the average slowing time was **195 sec**. After 48 hours of work the measurements were repeated, and the slowing time already equaled **315 sec**. All these facts speak for **significantly diminished friction**.

The wear cavities were found to be filled by the mineral material, and practically only traces of cavities were seen. No additional treatment of the slider bearings was needed!
